**The MacFarlan House:
A Survey of an Okie-Designed Work in Progress**

Rebecca Angeline Geist

A THESIS

Historic Preservation

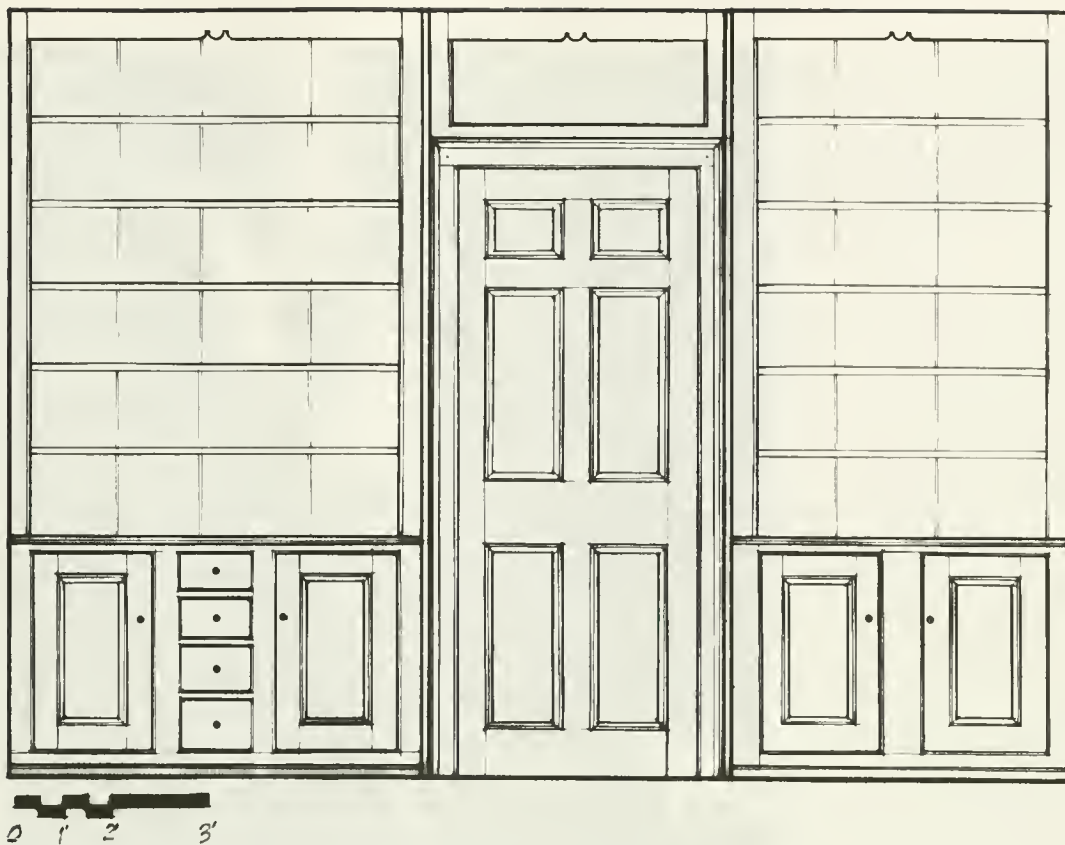
Figure 3.32a Study, West Elevation The bookcases are explicitly detailed with the characteristic Okie "scallop" appearing at the top of each section.

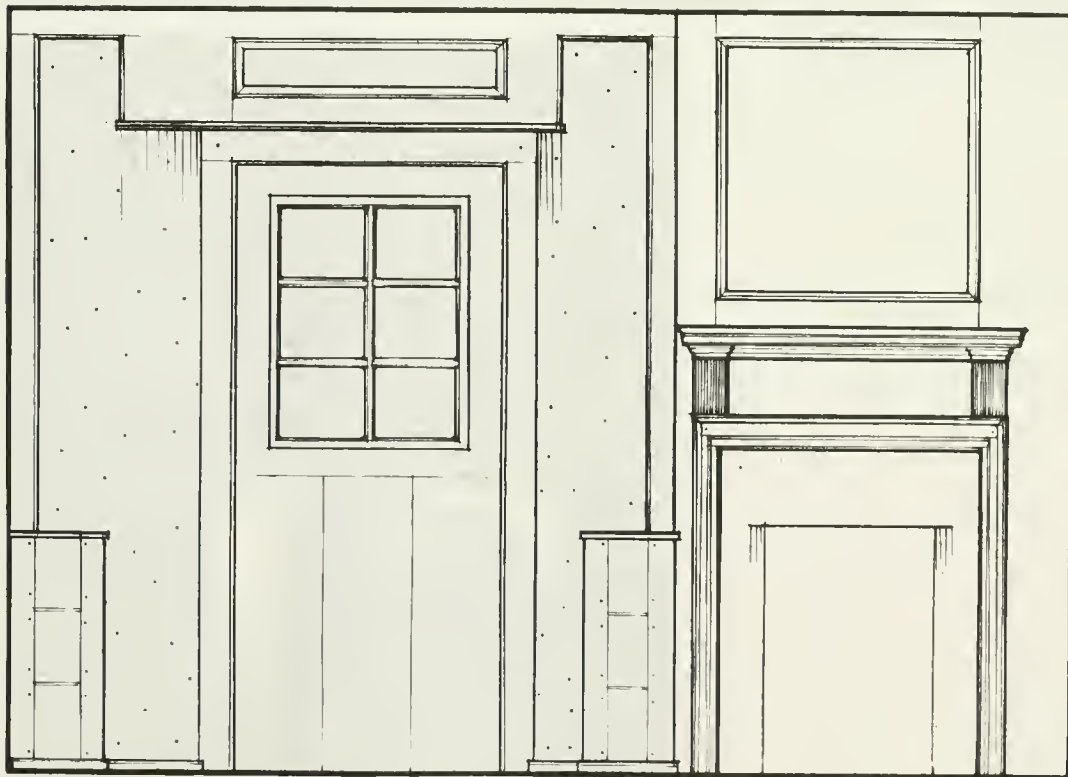
Figure 3.32b Study, East Elevation This wall incorporates a door to the east porch. The plaster curves around the thick stone walls to meet the door trim, as does the base board. The fireplace is at a 45 ° angle between the south and east walls and has an Okie-designed mantel with a single raised panel above (Drawings surveyed and adapted from Okie prints).

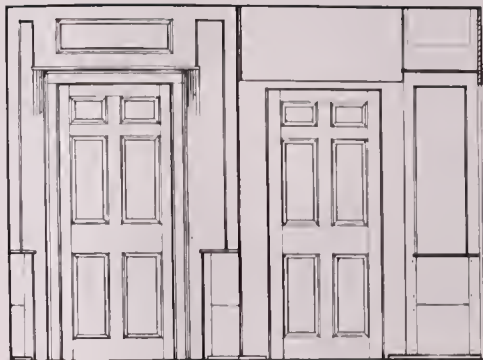
Figure 3.36a East Hall, South Elevation This wall is two distinct levels. The one further back is the door into the library. Here, the plaster curves to meet the door jamb, but the baseboard does not. The section further up is the door to the basement and the adjacent wall. This wall is very complicated due to the sloping ceiling above.

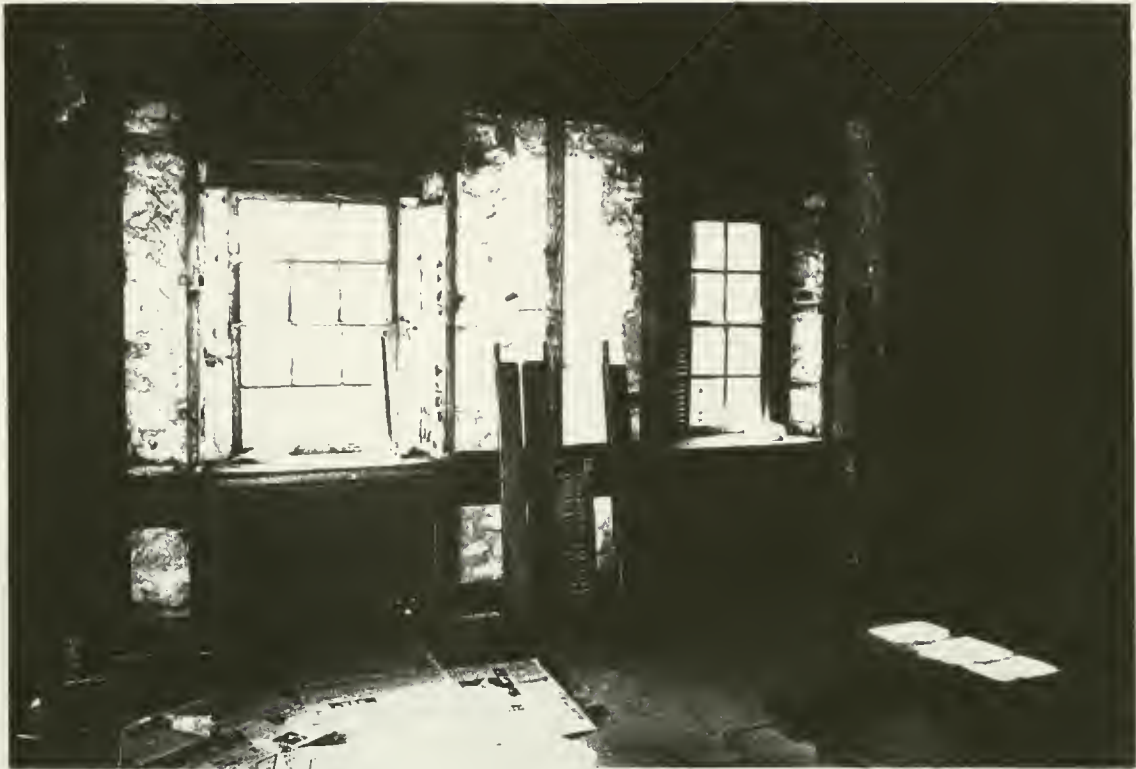
Figure 3.40a Master Bedroom (Bedroom D), West Elevation The wood for this room is a natural finish cherry. Notice the 12" chair rail running across the wall. This detail is unique to the interior of the MacFarlan house, though used on the exterior porches. The top and bottom of the chair rail is profiled to receive plaster. One radiator is placed under the south window, while the north window void was designed for a small cabinet.

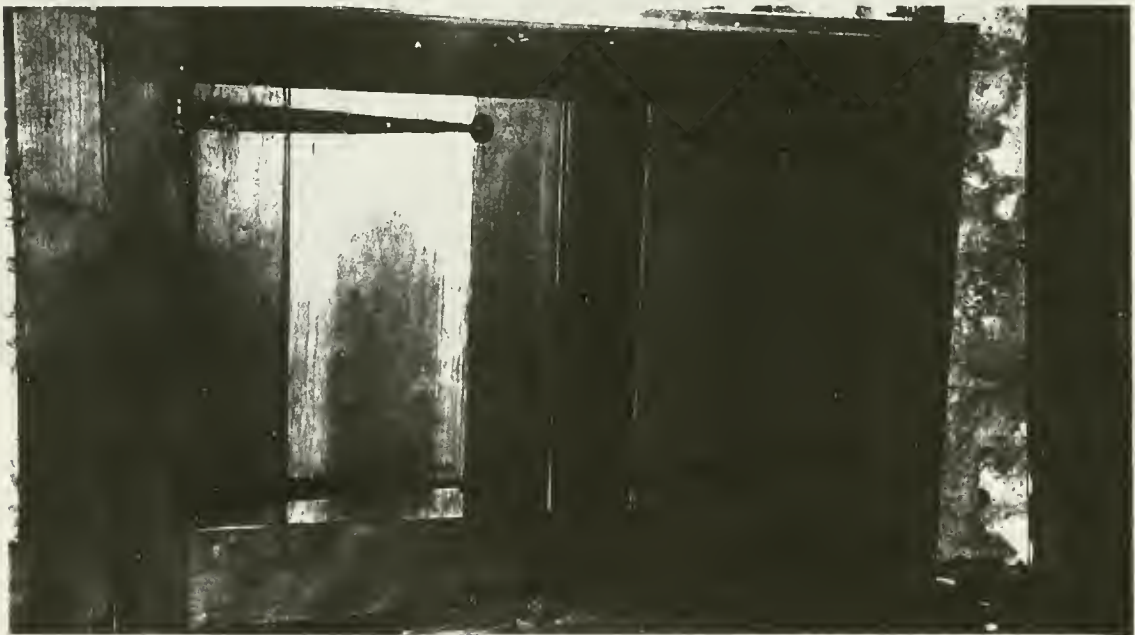
Figure 3.40b Master Bedroom (Bedroom D) A small cabinet is inserted in the void below the window sill of the west wall. The small cabinet has a beaded board front and is held by small strap hinges on pintles. Upon examination of the interior of the cabinet it becomes apparent it is held together by screws, though the beaded boards are tongued and grooved.

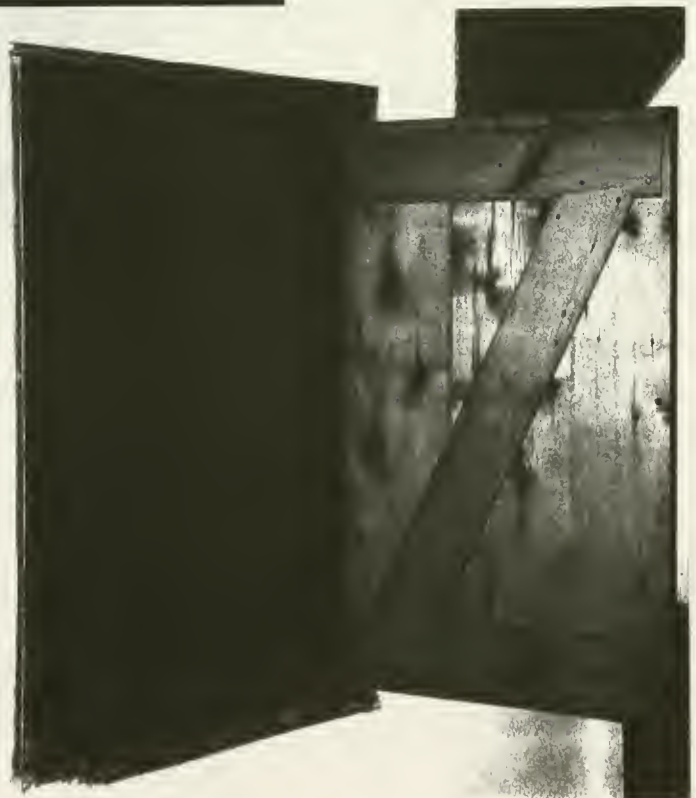
Figure 3.41b and 3.41c **Servant's Quarters, West Wall** The cabinet lies to the right of the previously mentioned cabinets. This door leads to a large storage space under the eaves of the rear porch. It appears the jamb is made of recycled wood, as paint remnants and the inconsistency of a small head running across the top and not meeting a head to the sides. The threshold of this cabinet is a large, flat stone.

The Servant's Room does contain ample storage space along the east wall (Fig. 3.41a). The southern-most cabinet is very unique in that it rests on a stone base and its jamb appears to have been constructed of antique beaded lumber (Figs. 3.41b and 3.41c). The newel post for the small staircase is beaded within inches of its top, similar to those designed for the front terrace, only on a smaller scale. Both windows in the room have plaster surrounds and hide small radiators underneath. The ceiling joist in this room stretch across from east to west and are pegged into the rafters which are exposed along the west wall (Fig. 3.41e).

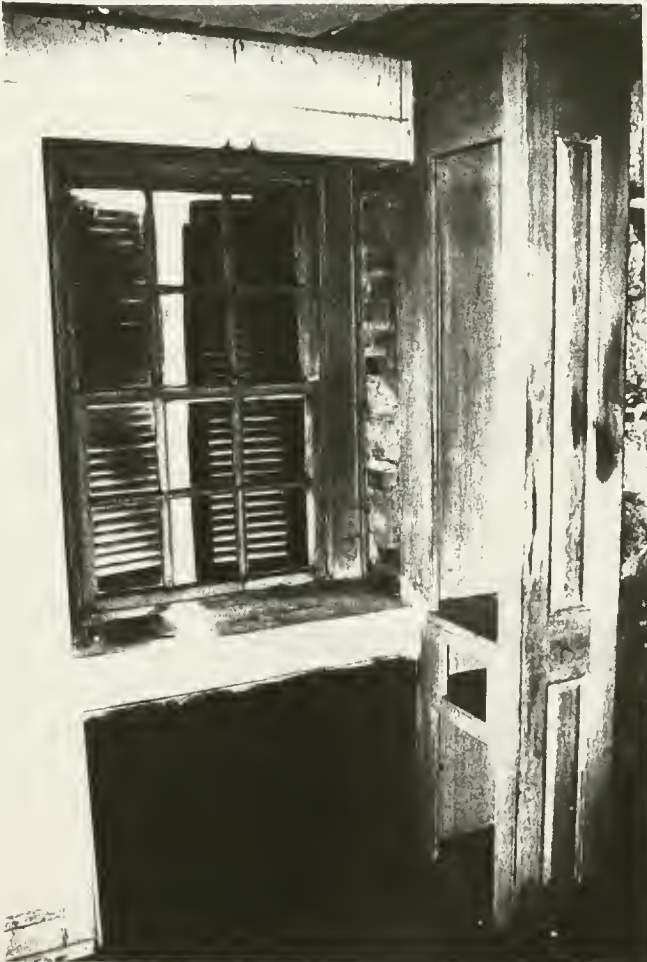
Figure 3.42b Gun cabinet and window. Notice the small scallop detail at the top of the window.

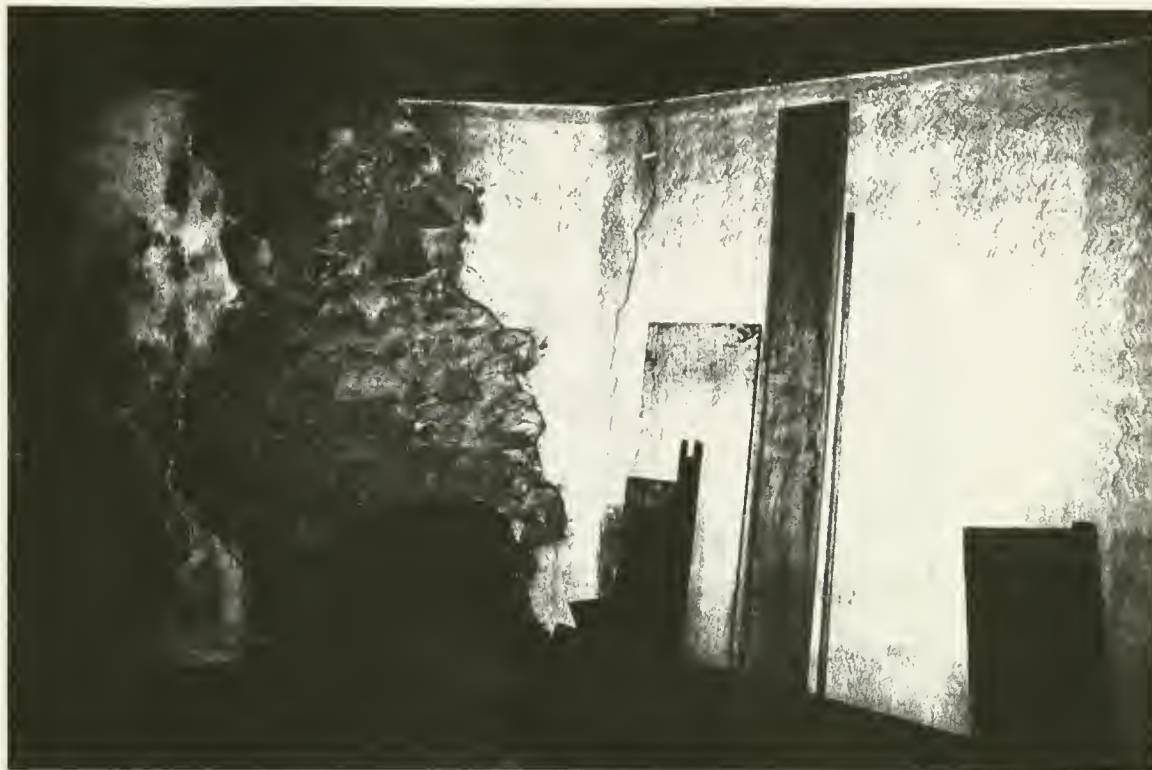
Though drawings for this room by Okie have never been found, he did add a small fireplace in this room where there was not one before (Fig. 3.44a). The hearth in this room is stone and is semi-circular. The floorboard surround is also curved to match the hearth and individual boards are dove-tailed to one another to form the perimeter (Fig. 3.44b)

Figure 3.44a Bedroom C, East Wall The wall is at a 45° angle to the south and east walls. Okie added this fireplace, but no drawings or descriptions as to its design have been located.
